V.A.C.VIA™ NEGATIVE
PRESSURE WOUND
THERAPY

V.A.C.Via™ Negative Pressure Wound Therapy Case Studies

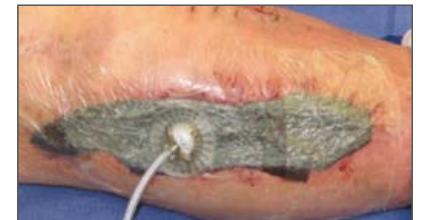
Figure 7. Case Study 1:

C) Application of V.A.C.Via™ Therapy System over STSG

Dehiscence after open reduction of tibia fracture.

On postoperative Day 6, the patient returned to the outpatient clinic and the V.A.C.Via™ Therapy dressing was removed. There was an approximately 100% graft take with good aesthetic results.

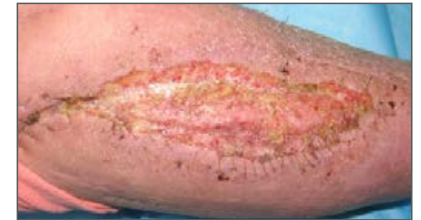
D) Wound on postoperative Day 6 after V.A.C.Via™ Therapy dressing was removed

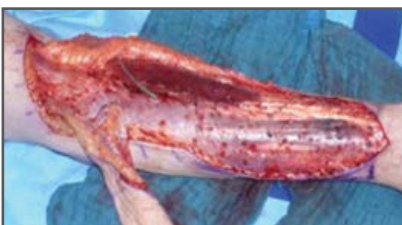
Figure 8. Case Study 2:

A) Soft tissue findings after debridement before mesh-graft coverage

A 62-year-old male patient presented with a fracture to his left leg due to a traffic accident while riding a bicycle. A free radial forearm flap transfer was used to cover the defect. Treatment of the donor site required multiple surgical interventions and subsequent meshed STSG. A V.A.C.Via™ Therapy dressing was applied at the donor site for 5 days, resulting in good healing of the STSG (Figure 8 A-C).

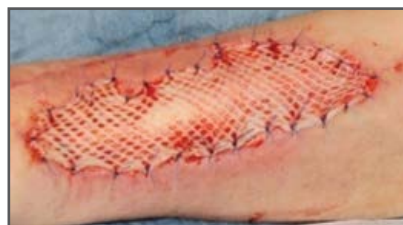
B) Intraoperative after mesh-graft coverage

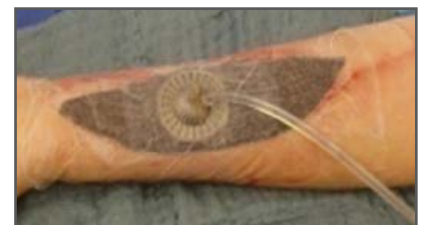
C) V.A.C.Via™ Therapy over mesh-graft coverage

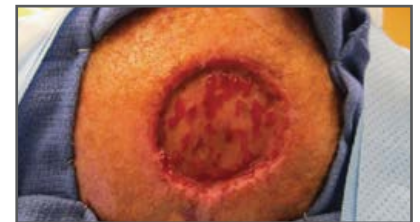
Figure 9. Case Study 3:

C) Postoperative Day 24 after application of V.A.C.Via™ Therapy System over Integra® and before STSG

On postoperative Day 5, the patient returned to the outpatient clinic for follow-up and removal of the V.A.C.Via™ Therapy dressing. The Integra® graft appeared intact and viable. Following availability of final pathology revealing clear margins, an STSG was placed on post operative Day 24. A non-adherent layer and V.A.C.Via™ Dressing were placed over the STSG. V.A.C.Via™ Therapy was discontinued 6 days post STSG with 100% take of graft reported.

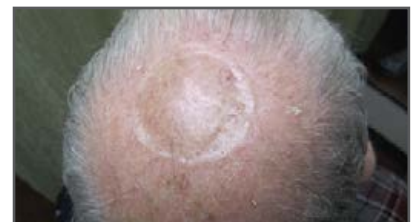
F) Follow-up - 4 months Post-STSG

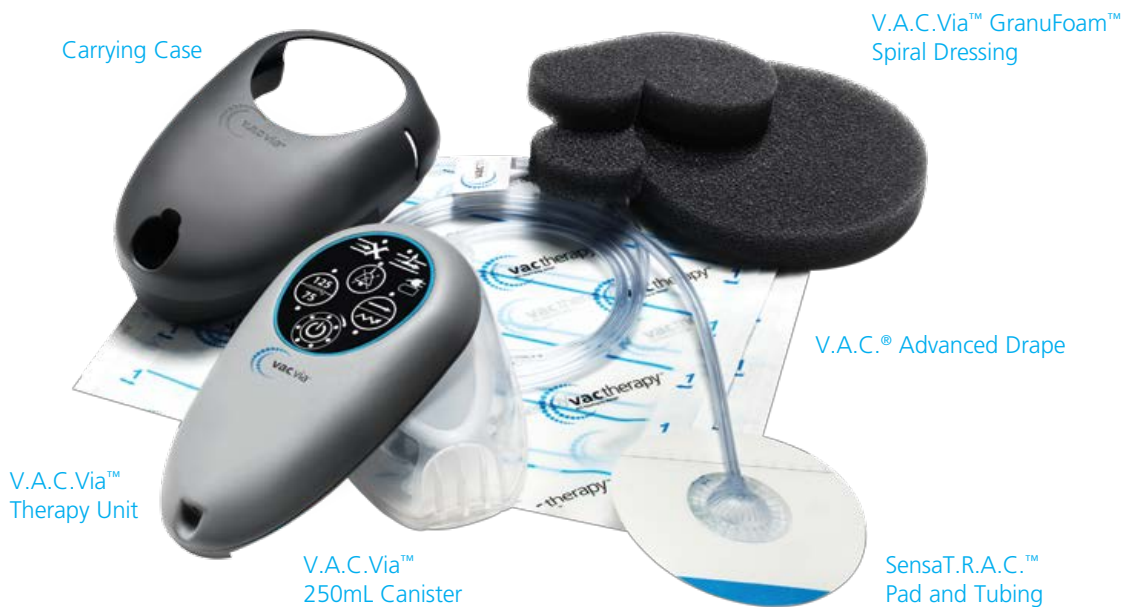
The V.A.C.Via™ Negative Pressure Wound Therapy System consists of the following components:
